United States Department of Agriculture  
Natural Resources Conservation Service

# HUNTSMAN LAKE DAM REHABILITATION PROJECT

Pohick Creek Watershed, Fairfax County

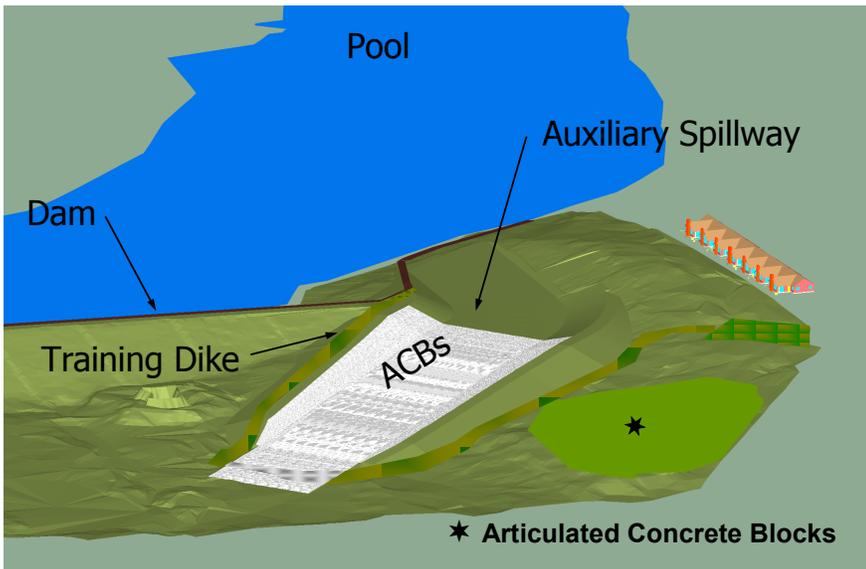
Above: Existing riser at Huntsman Lake.  
Below: Example of closed top riser.

- During a storm that delivers more than 11 inches within 24 hours, the soils in the auxiliary spillway will erode and could cut completely through the auxiliary spillway, which would cause the dam to lose all its storage capacity; and
- The principal spillway riser does not meet current safety criteria because of the open top.

The principal spillway riser will be replaced to improve public safety and to prevent clogging by floating debris.
